TDP 12 - Bioremediation of the Coke Works and Former Colliery at Askern, Doncaster

Originally published July, 2005

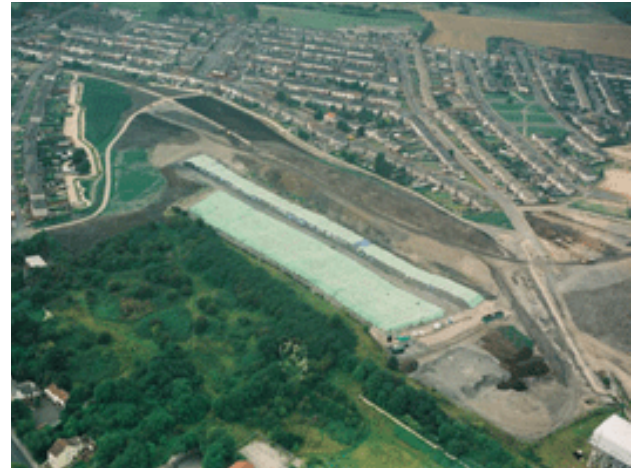
Aerial view of the two biopiles at Askern

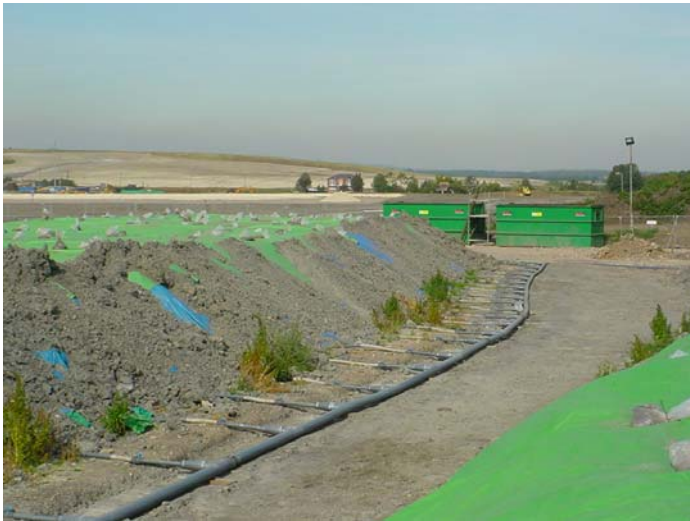
Side of the biopile showing aeration pipes

Biopiles are static, engineered, soil piles which have aeration lines installed to facilitate the active transfer of gases through the soil, thereby providing oxygen for the bacterial population. At Askern the aeration was induced with a vacuum blower.
